DEVON &
SOMERSET
FIRE & RESCUE SERVICE

Cathedral Yard Exeter Fire

Devon & Somerset Fire & Rescue Service

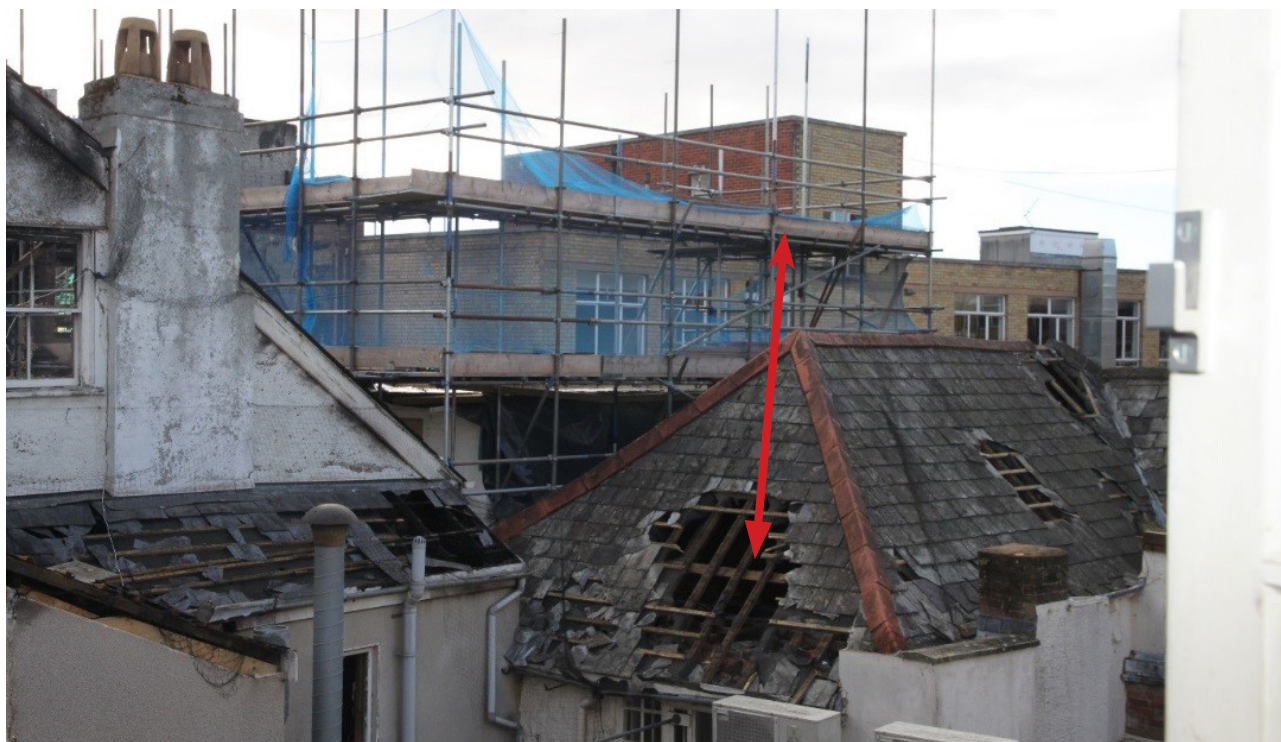
Fig.3 This picture is of number 18 where the fire originated and spread to the RCH. The arrow shows the scaffold around the rear of number 18 where the building is wide open and indicates the reduction in height by two floors and how the fire may have spread. Photo taken 1/11/16.

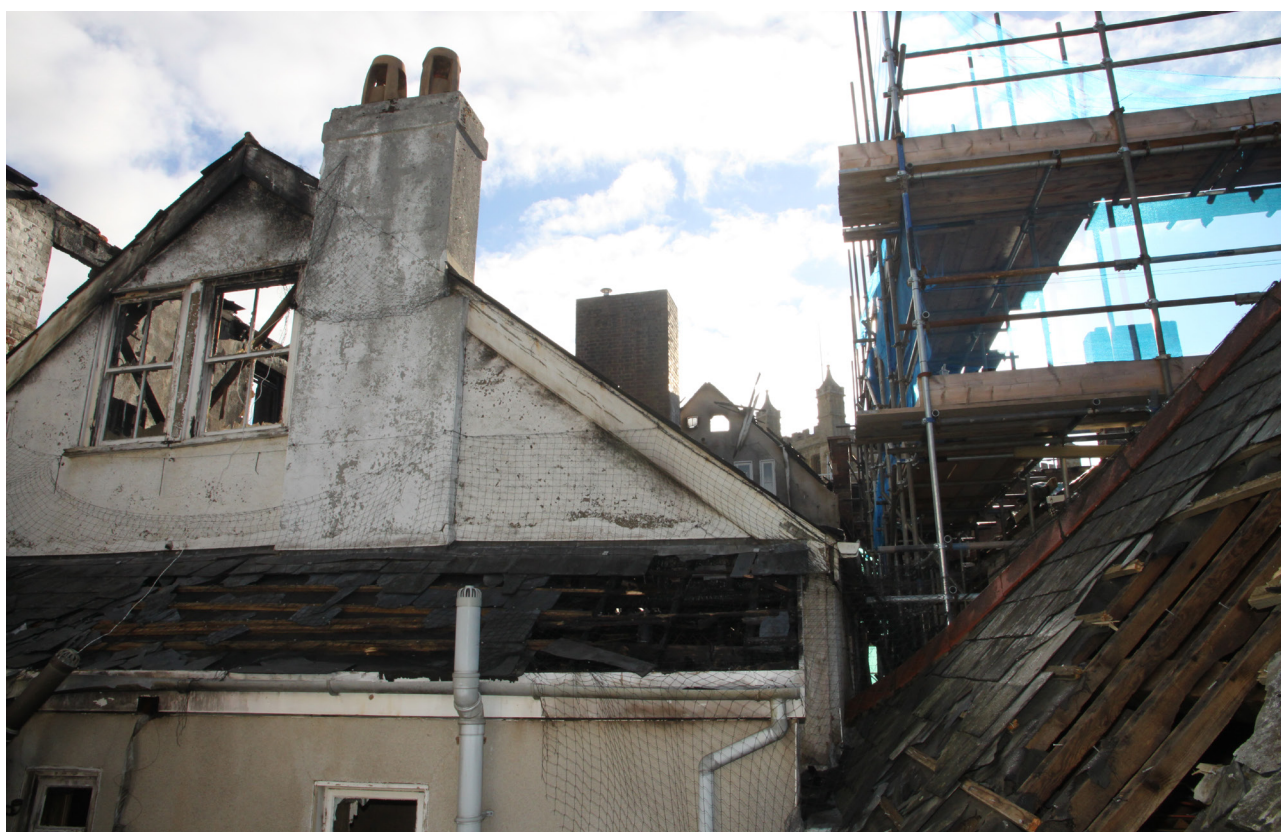
Fig. 4 This picture shows the hotel to the left and number 18 to the right. The reduced building height of number 18 allowed the dramatic fire to impinge on the hotel at the very early stages. Photo taken 1/11/16

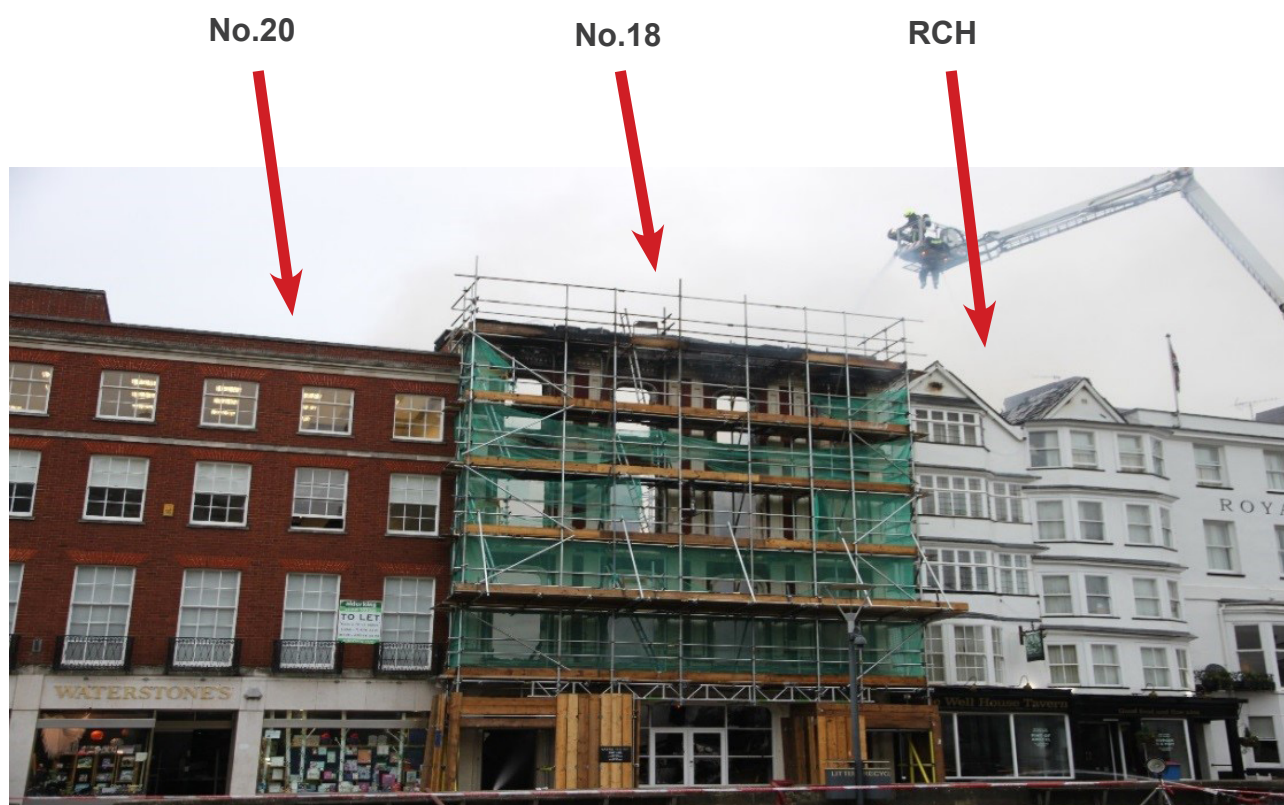
Picture taken 10:27 on 28th October 2016 shows internal collapse of number 18 due to the significant fire. The fire spreading and developing within the RCH, compared to the modern building construction in No. 20 which did not sustain any fire spread or damage.

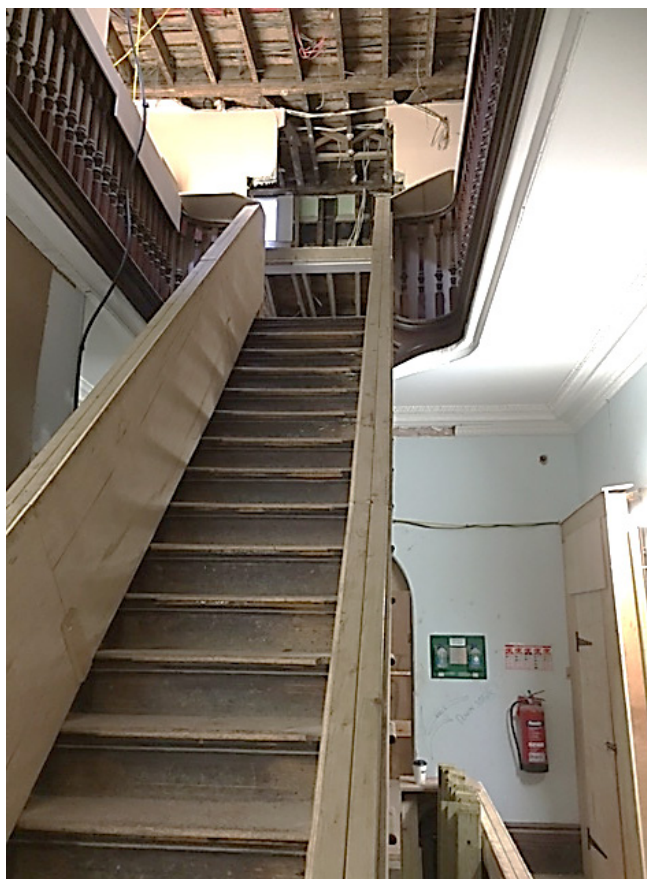
This photo shows No 18 prior to the fire during the construction phase. Note that the floors are open and not compartmentalised, allowing fire to travel easily.

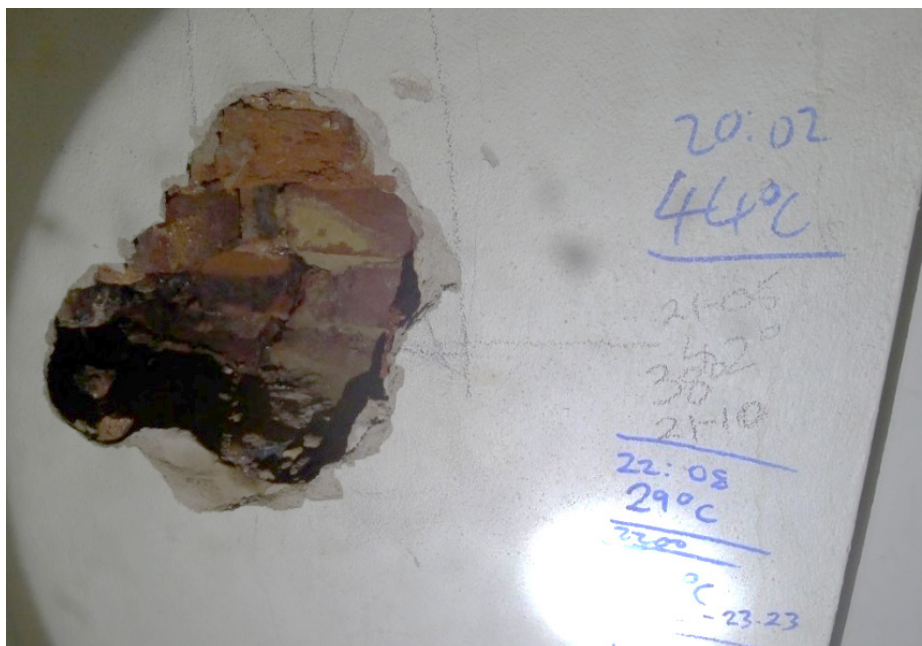
Crews using a thermal imaging camera identified a heat source behind a plaster wall and this led to the removal of the plaster and location of a burning timber beam behind. The writing on the wall shows where the fire crews were recording the temperatures.

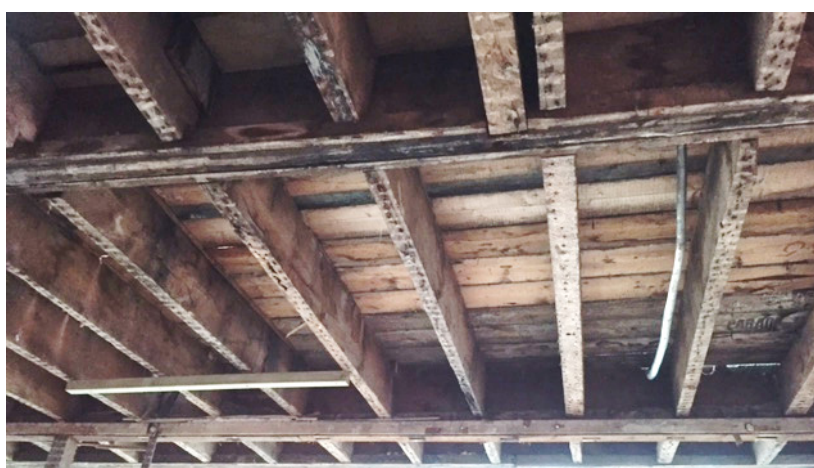
This picture shows the floor from above. Made completely of timber, but unprotected with a ceiling material.

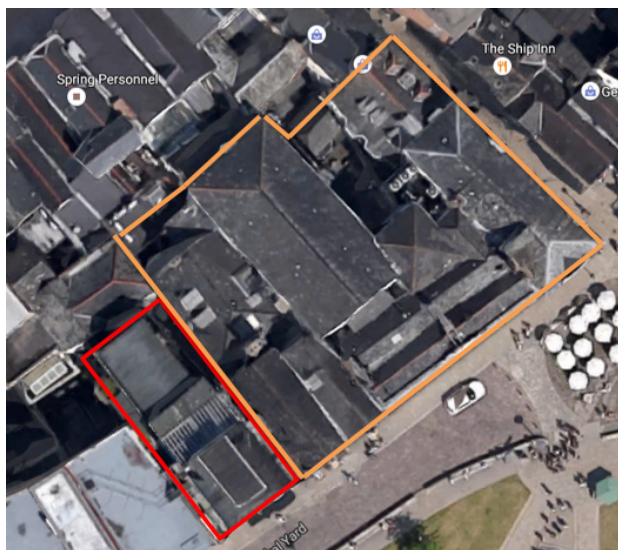
Heritage buildings and terraced properties can have a 'common' roof void. This is where the roof extends from one end of the property to the other or large sections of roof space without any separation from the individual properties.

Many compartment walls do not continue up into the roof void, or are compromised by openings, thus permitting the unhindered and rapid spread of fire along the roof space, and it was not until 1850 when the requirement for compartment walls to continue into the roof space came into effect.

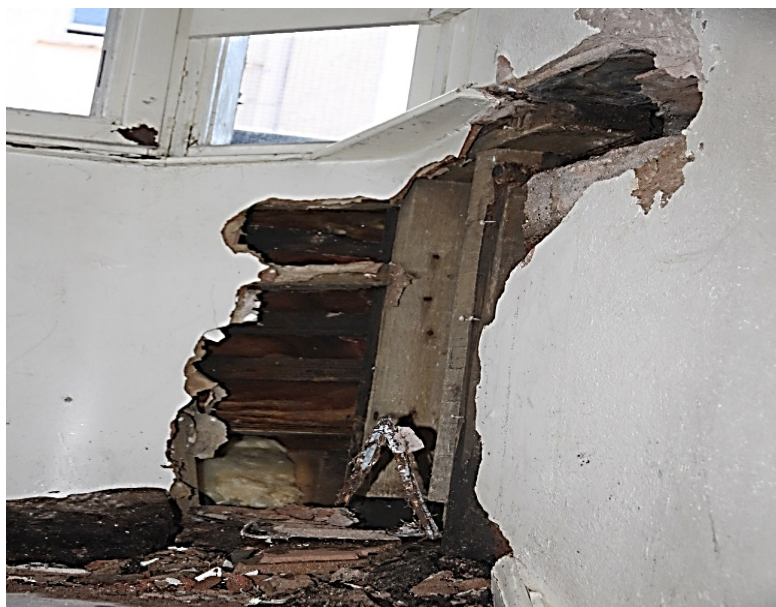
This picture shows where firefighters have removed part of a wall to reveal a void which had undetected fire and smoke spread.

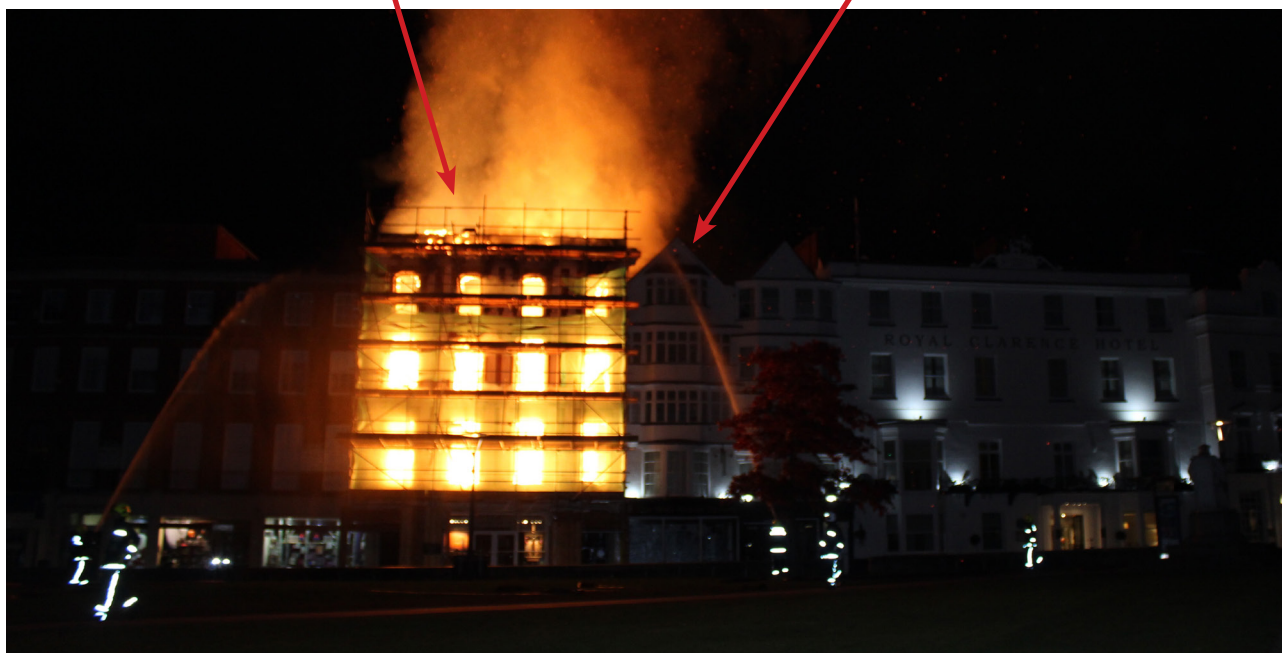
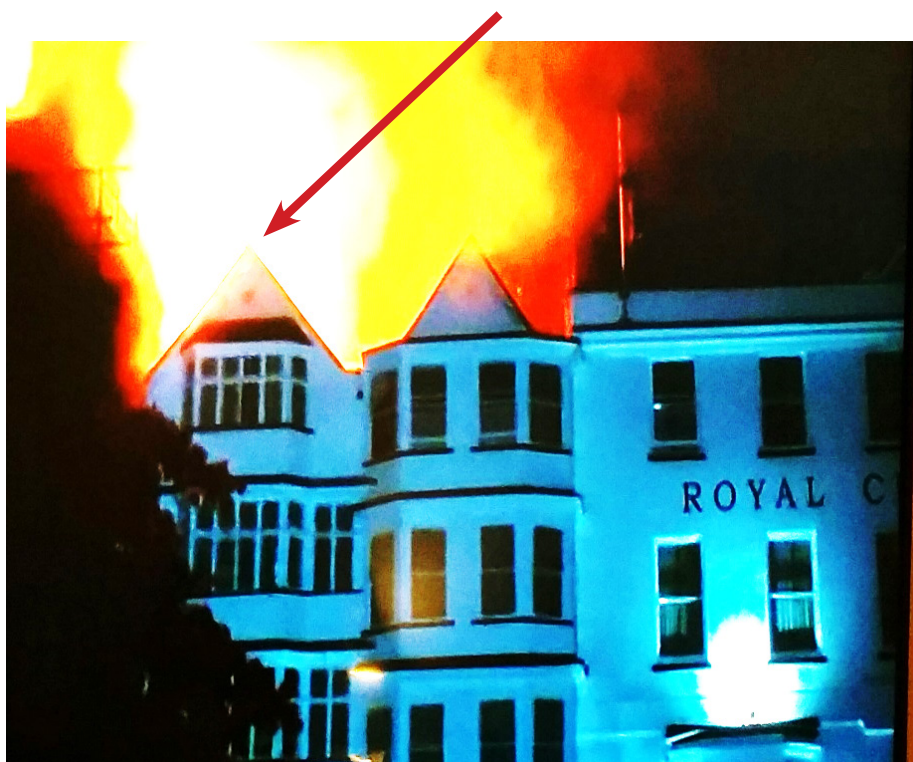
Fig 8 & 9 show that the first attending crews were faced with a significantly developed fire which appears to be showing fire and heat not only within number 18, but at the rear of the hotel.. (Pictures taken prior to the arrival of DSFRS) picture courtesy of guest N. Groom taken at 05:13

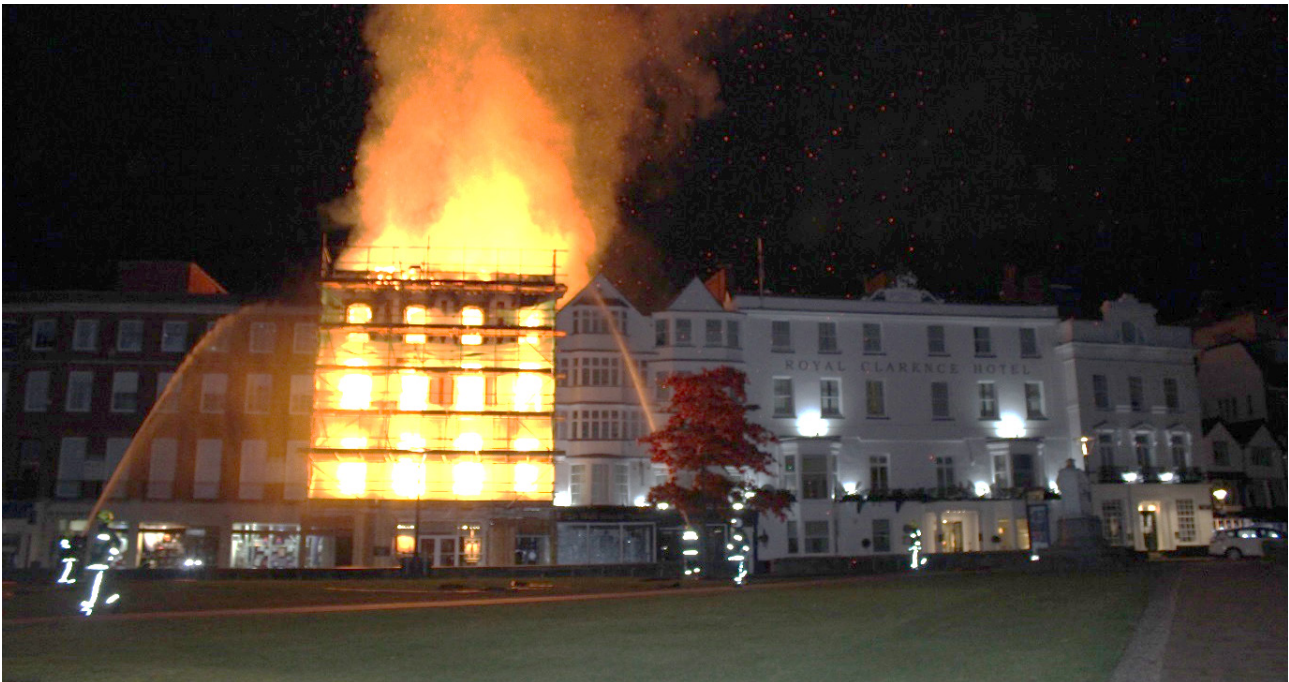
Fig 12. Sector 1 showing number 18 fully involved in fire courtesy of guest N. Groom

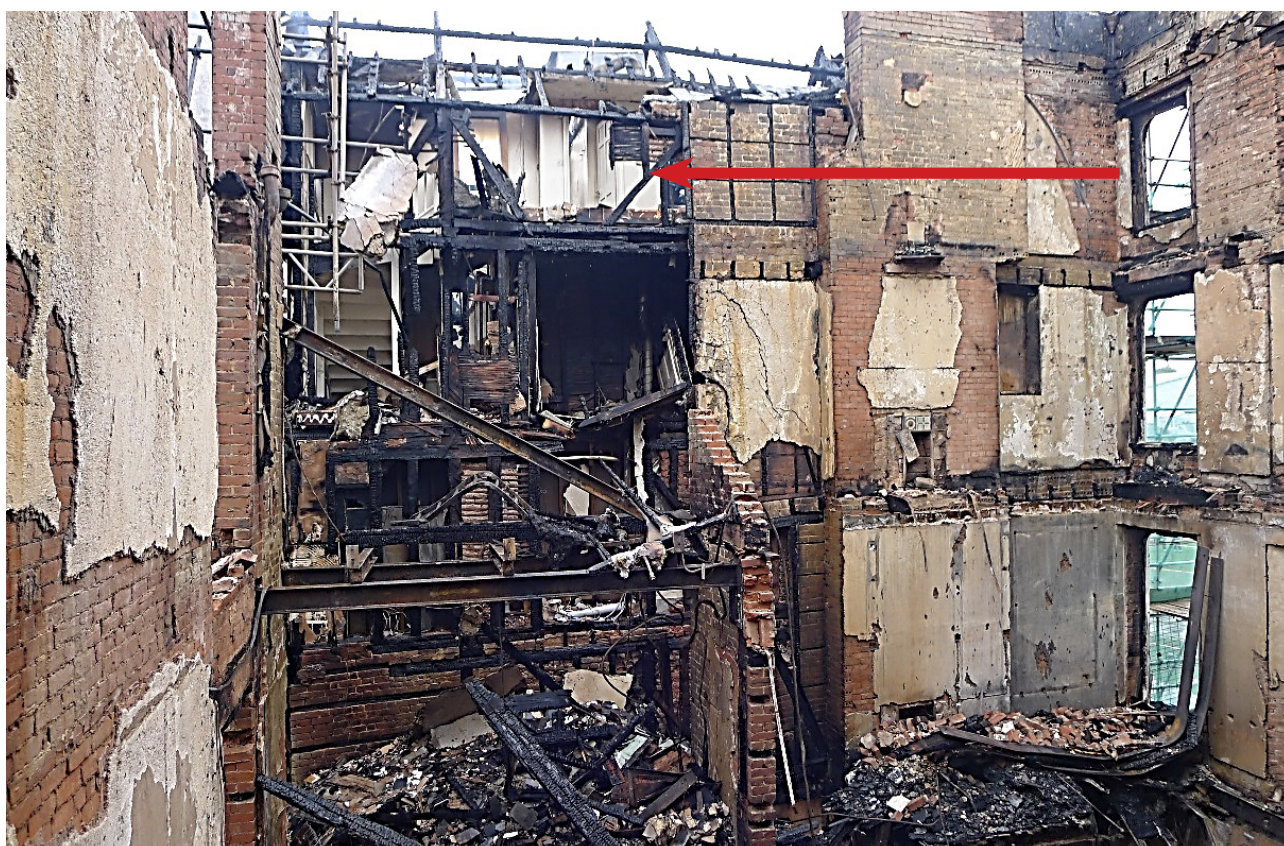
Fig 17. Photo taken post incident from the Waterstones building showing where the BA crews entered room 402. The arrow indicates where the wall had fallen away as the BA crews made their way along the hallway. The collapse of the wall revealed the raging fire within number 18 (in the forefront of the pic) which led to the decision to remove internal firefighting crews.

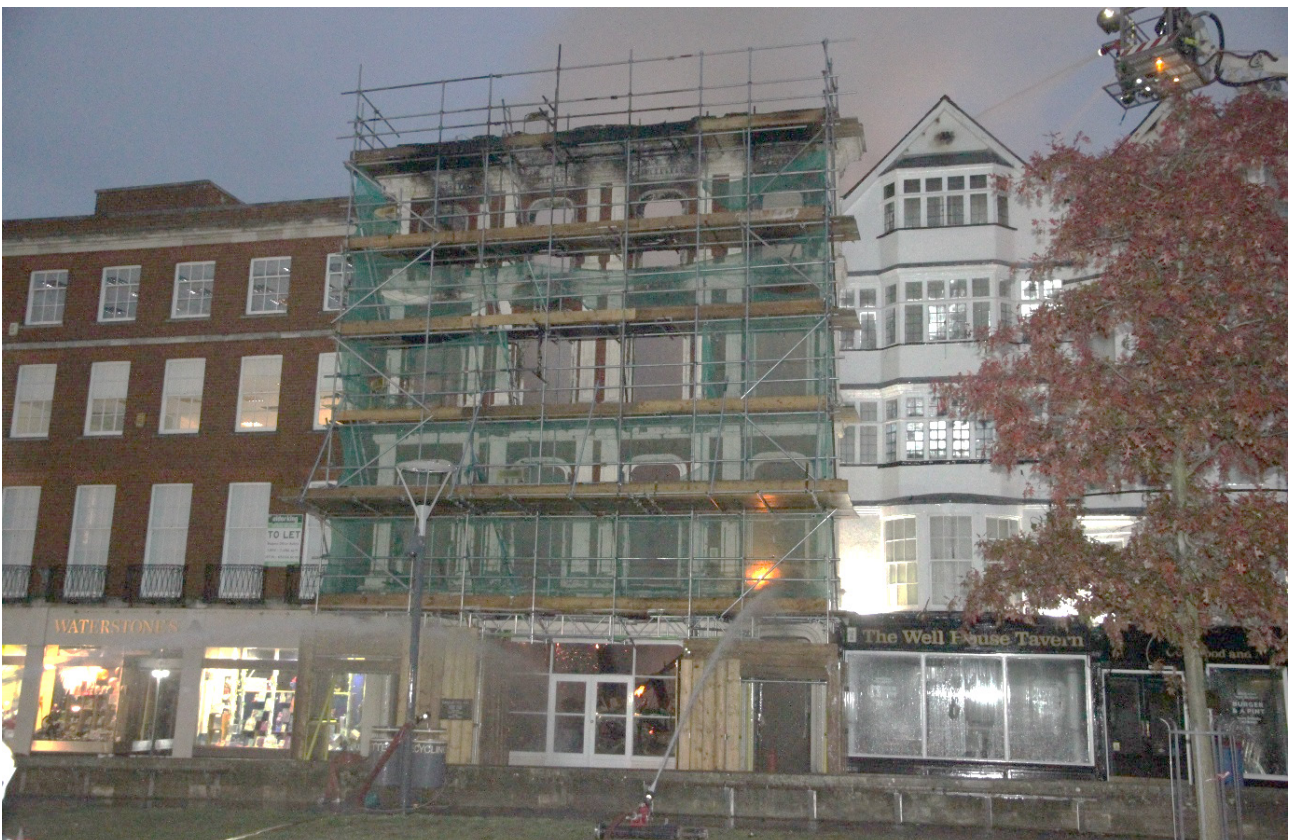
Fig 19. Picture showing the internal collapse within No. 18 and still shows the glow of the fire at the top rear of the building. Photo taken at 06:53

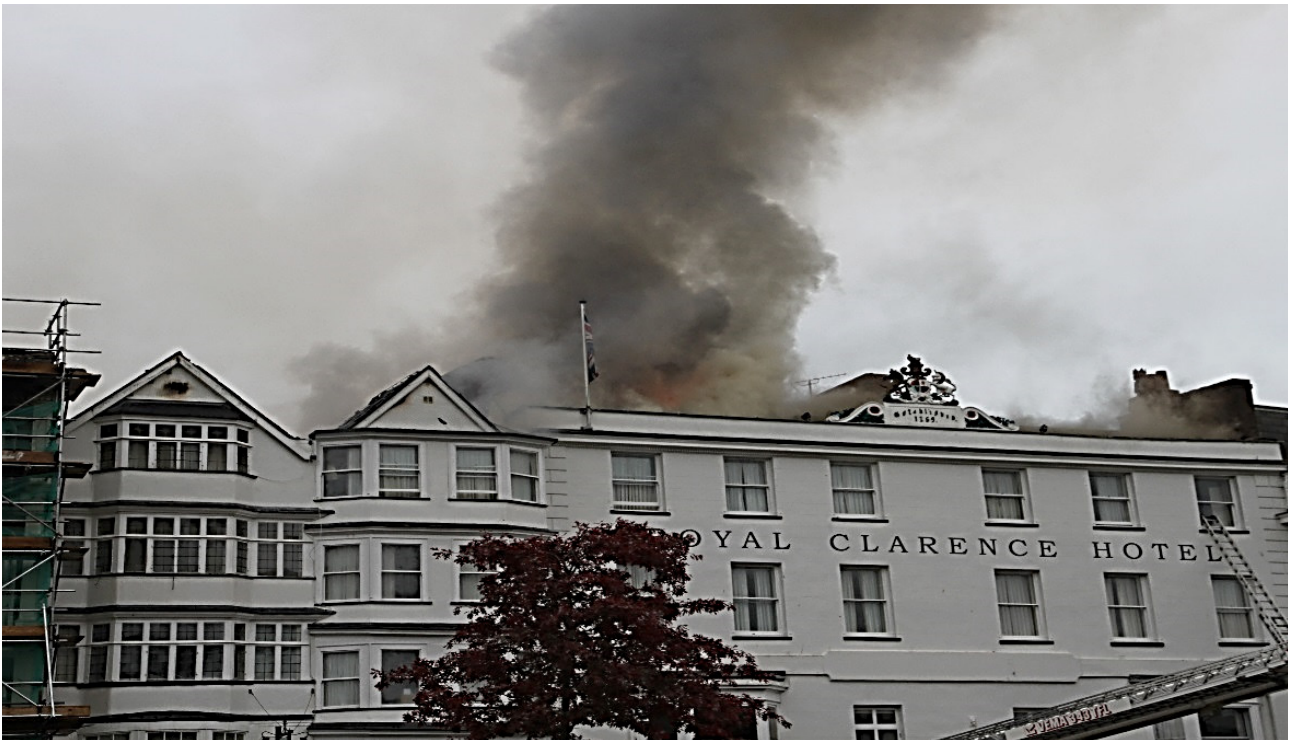
Fig 22. Picture showing smoke and fire development from the middle of the RCH roof

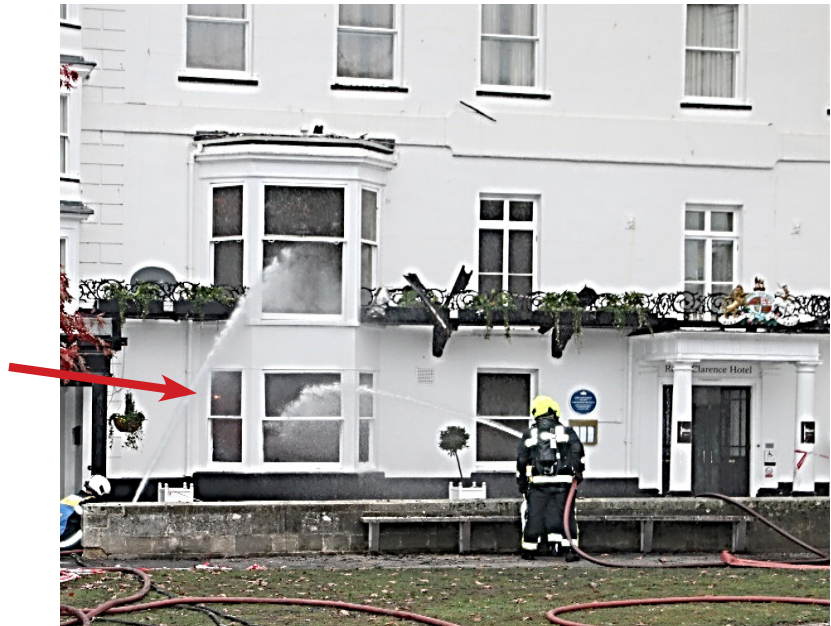
Fig 25. This picture shows Sector 5 St. Martins Lane. The arrow indicates the section of the building that required monitoring.

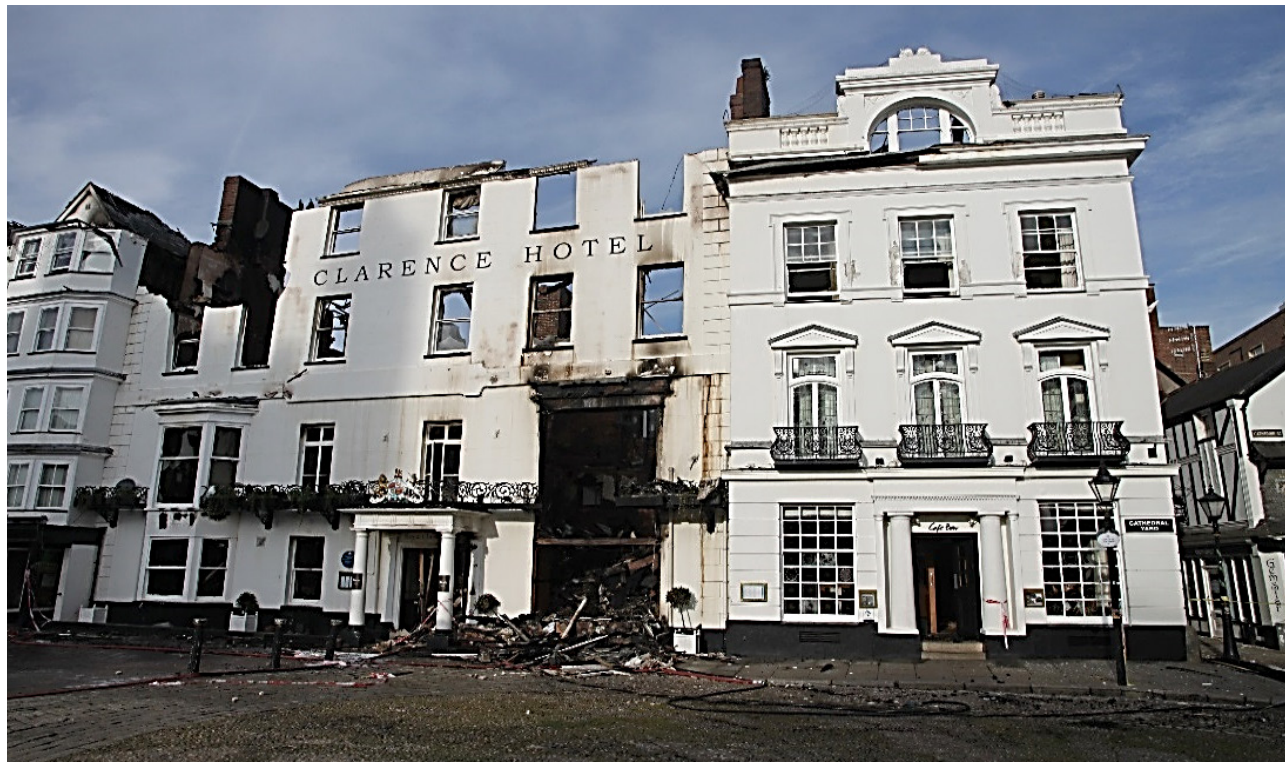
Fig 27. This picture shows the devastation caused to the RCH, it also shows the entrance to St. Martins Lane which was saved from fire and smoke damage.

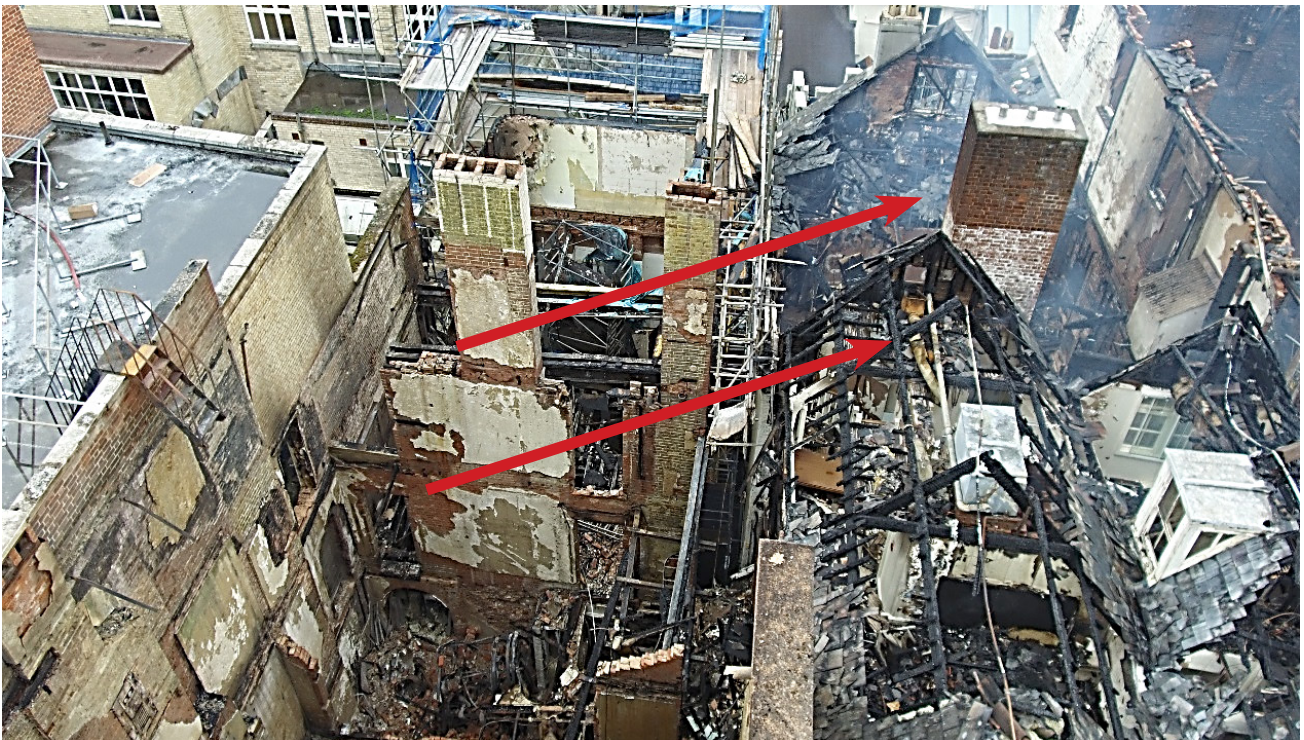
Fig 30. The picture above shows number 18 and the total collapse and the fire spread into the Royal Clarence Hotel

There are signs from the floorplans within Appendix 4, of wide open spaces, such as the Clarence room and ducting, as well as voids, staircases etc. that may provide an understanding of the fire spread and sudden rapid escalation that led to the travel and spread of fire and unburnt combustibles and smoke.

- It is recommended that automatic fire suppression is fitted where needed, including within hidden voids to provide early detection of heat and fire spread and therefore able to provide immediate suppression. (CFPA, 2013)
