Ministry of Housing, Communities and Local Government Release Copy of Fire of Special Interest Report

Grade II listed property under renovation, Exeter, Devon, 28th October 2016

Prepared for:	Brian Martin
Date:	08 November 2018
MHCLG Contract:	CPD4118106
Report Number:	P113186-1019 Issue: 1

FSIS Ref. No: 04 – 16/17

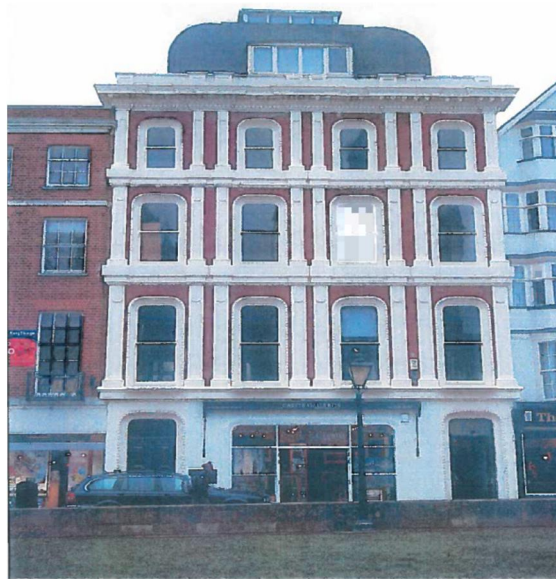
The building where the fire started (18 Cathedral Yard) is a five-storey Grade II listed property. The front façade comprises four storeys beneath a steep-sided, square dome terminating in a lantern, see Figure 1. The building occupies a long, narrow plot extending towards the rear of a group of three properties. The subdivision of the large early tenements into the present smaller and narrower plots fronting onto different streets is reported in fifteenth and sixteenth century archaeological surveys, see Figure 2. Archaeological surveys indicate that the building of fire origin underwent a change of use from residential to commercial in around 1870.

Figure 1 – Façade of 18 Cathedral Yard
Image courtesy of Devon & Somerset Fire and Rescue Service

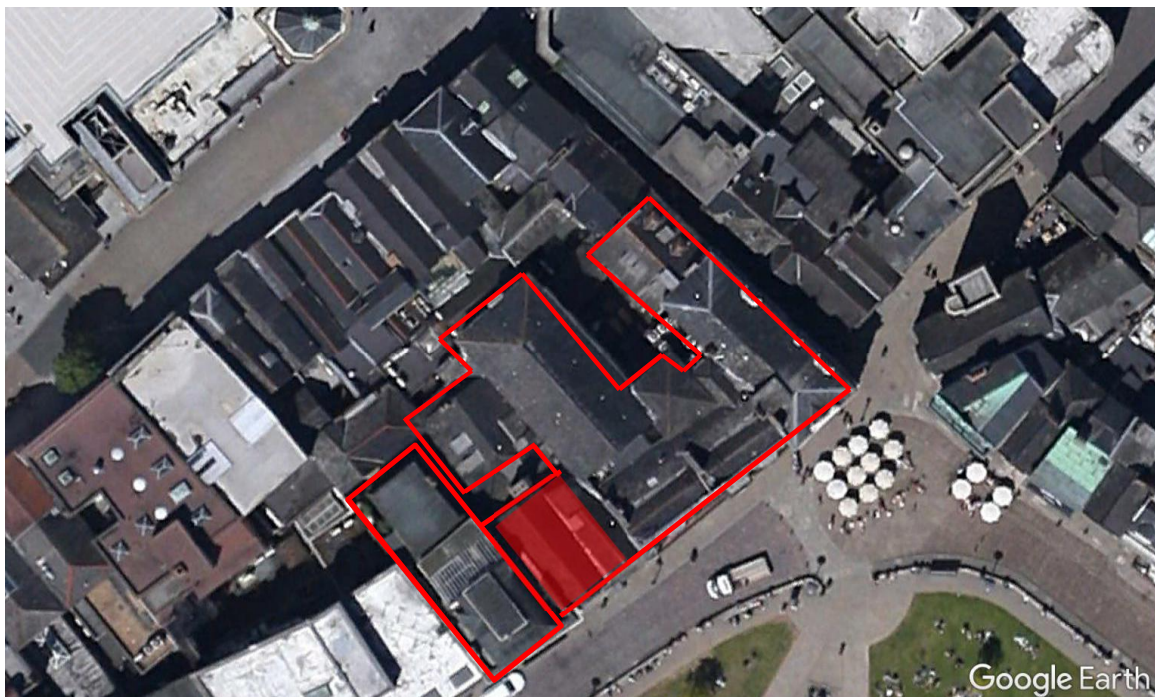
One part of the hotel was a pair of houses with medieval origins, see Figure 2 and Figure 6. These houses were extensively rebuilt in the late seventeenth century. Prior to the fire, it appears likely that medieval or late seventeenth century materials survived in the party wall between these houses and the building of fire origin. The fire exposed the different types of construction materials in this party wall; there were visible layers of bricks, timber frame with brick infills and timber frame with wattle and daub, see Figure 7. From inside the building of fire origin it can be seen that the party wall between this building and the next one was initially a facade of the neighbouring building. The bricked up window frame in this area would have originally provided a view from the neighbouring building towards the plot of the building of fire origin, above the location of the alley.

Figure 2 – Satellite image showing 18 Cathedral Yard to the south west and Royal Clarence Hotel to the north east (both outlined in red). The shaded red box indicated the location of two medieval houses which were subsumed into the hotel (© Google 2013)

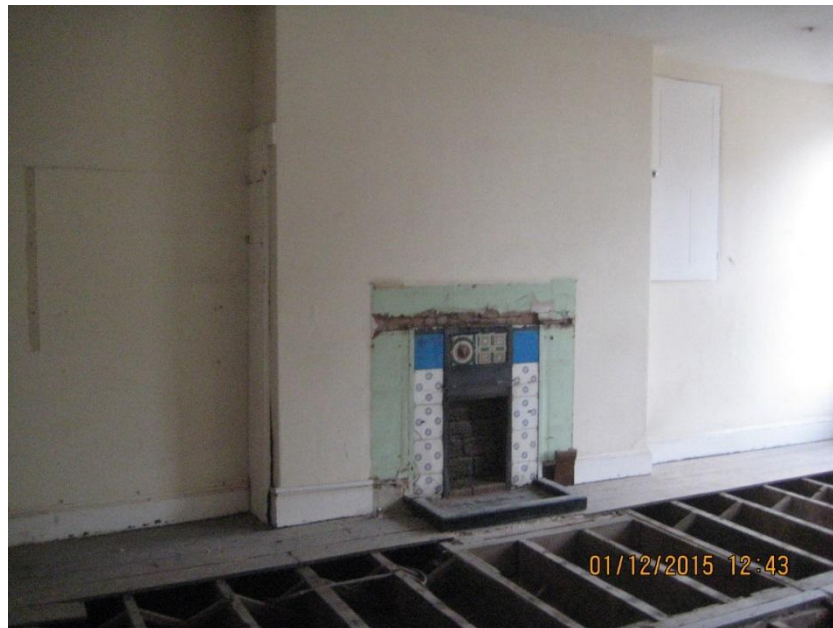
The building is understood to comprise an art gallery on the ground floor and construction of living accommodation in the basement and on the first and upper floors. At the time of the fire, all of the parts to be used as flats were undergoing significant construction/refurbishment work. It is understood that because of this, most of the internal partitions and floors in the flats had been removed, see Figure 3 and Figure 4.

**Figure 3 – Exposed floor joists with floorboards removed as part of refurbishment
Image courtesy of Devon & Somerset Fire and Rescue Service**

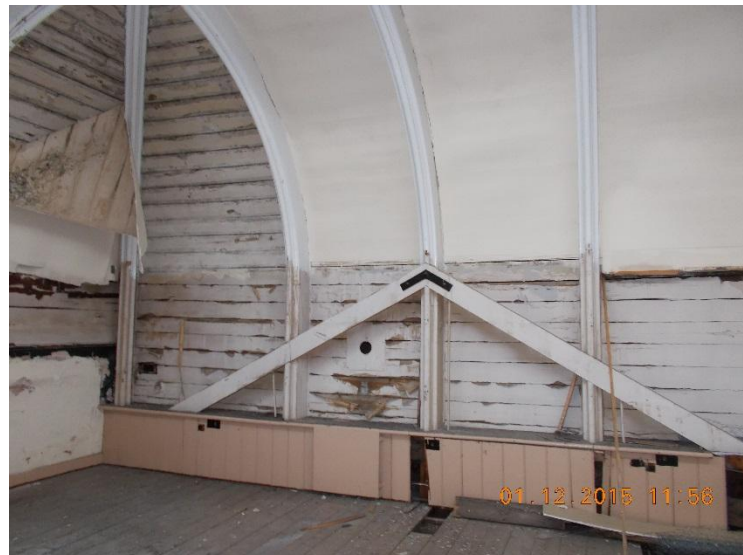
**Figure 4 – Exposed timber structure with plaster linings removed as part of refurbishment
Image courtesy of Devon & Somerset Fire and Rescue Service**

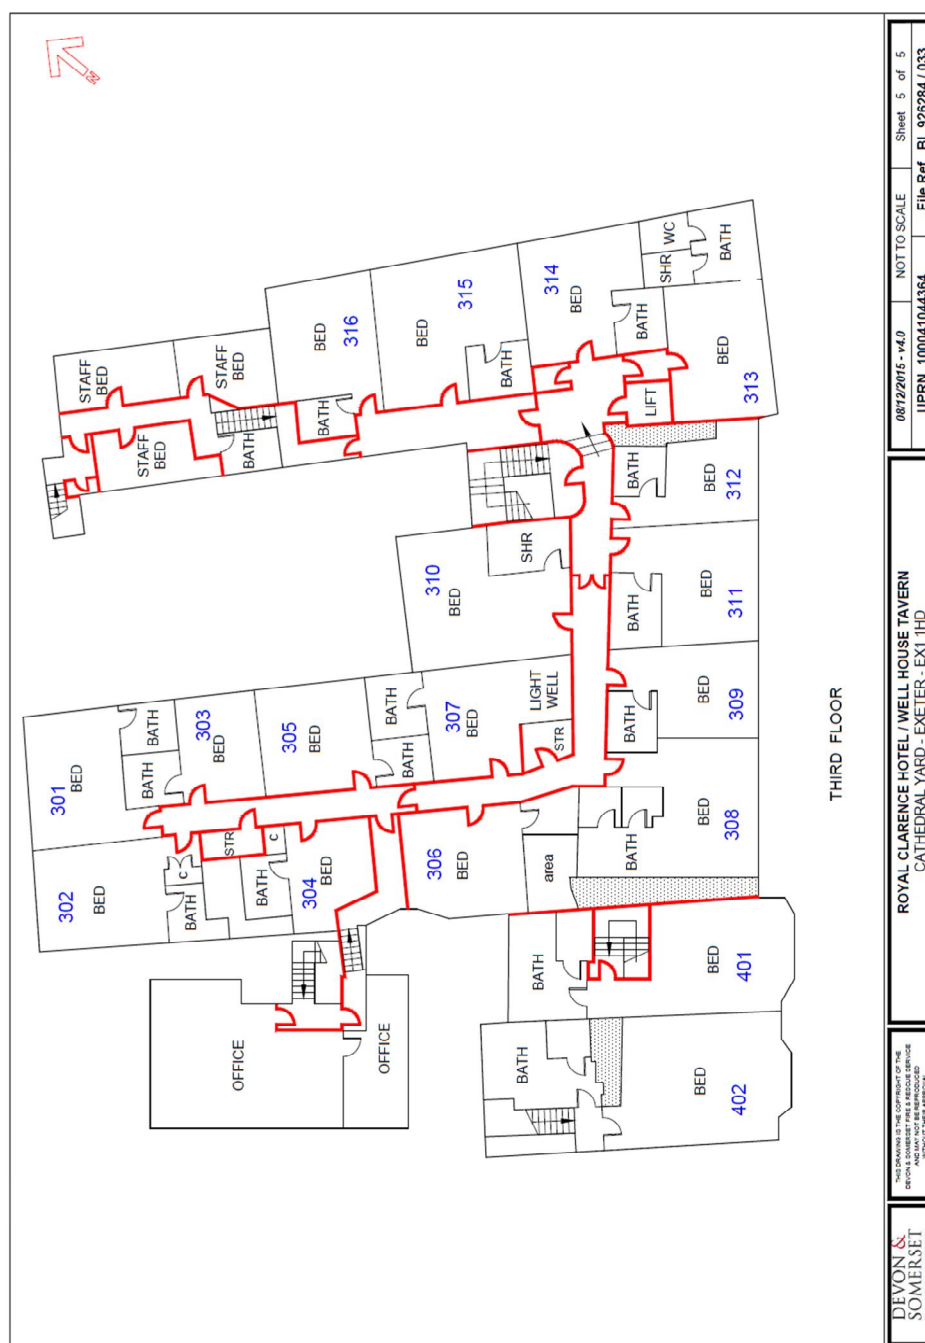
The hotel is four- to five-storeys which appears to comprise a number of premises (described in archaeological records as tenements) which have been joined to form a single building, see Figure 1. The hotel is Grade II listed and the main hotel building is understood to have been a hotel since 1769. The hotel is understood to have extended into adjoining properties over later years, although it is not known when these expansions occurred. The compartmentation layout of the hotel is shown in Figure 5.

Figure 5 – Plan of third floor of hotel. Note continuous compartment wall where there was a party wall between the medieval houses (separating rooms 401 and 402 from remainder of the hotel)
Plans courtesy of Devon & Somerset Fire and Rescue Service

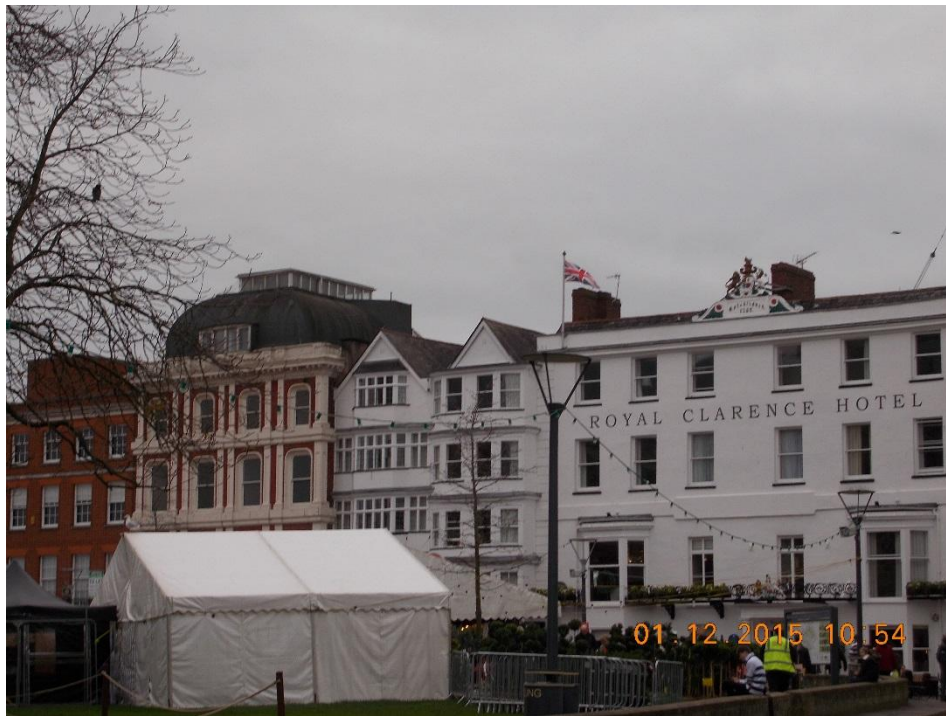
Figure 6 – Facade of 18 Cathedral Yard and the hotel, with the two former medieval houses which were subsumed into the hotel in between
Image courtesy of Devon & Somerset Fire and Rescue Service

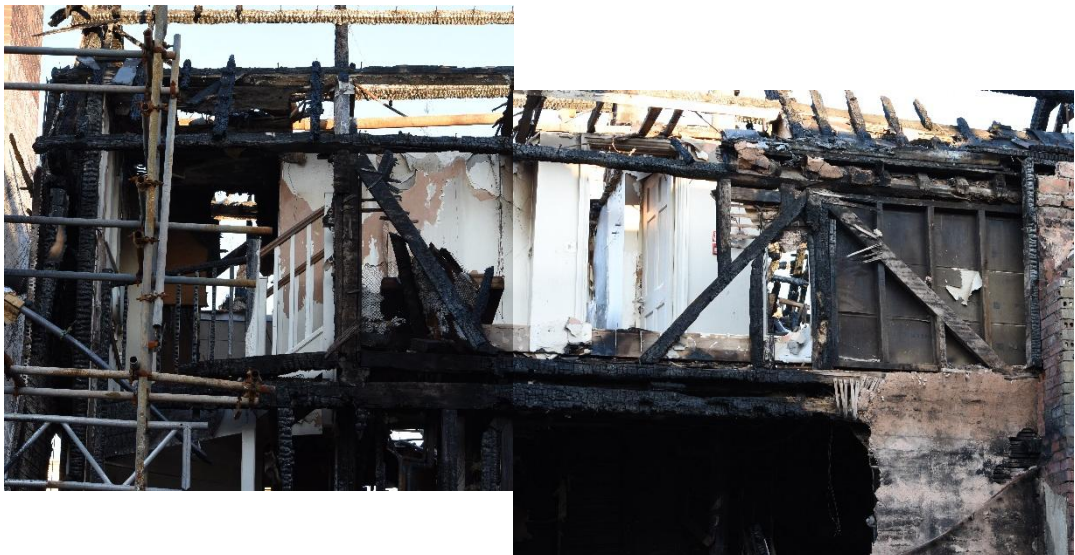
Figure 7 – Construction of party wall between 18 Cathedral Yard and the hotel, showing mixture of traditional wattle and daub construction (bottom right) and timber stud and plasterboard construction

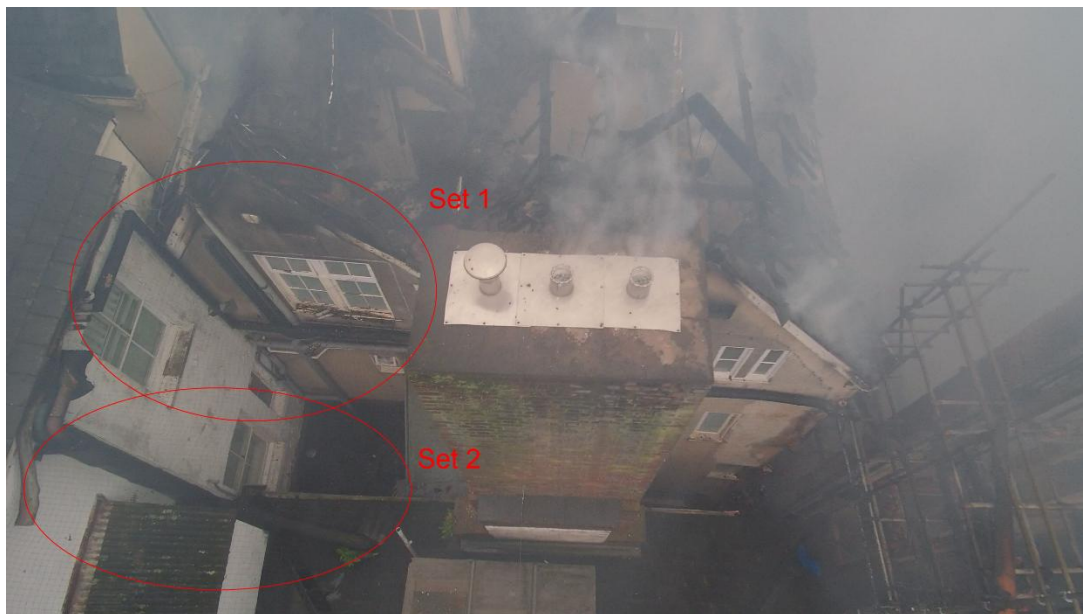
The roofs of the building of fire origin and the different buildings forming the hotel were all made from timber frame structure and in close proximity to one another. To the rear of the roofs of the medieval houses, there were pipes covered in lagging which appeared to be of a combustible material (polymeric foam), see Figure 8.

To the rear of the section of the hotel, formerly two houses, there were two sets of pipes which were lagged in what appears to be some form of combustible insulation. These pipes would not have been visible to Fire and Rescue Service personnel working from aerial ladder platforms. It is possible that fire may have involved the lagging on these pipes and spread from the rear of the former houses to the eaves of the roof over the main section of the hotel, see Figure 12. This is considered to be more plausible as it provides a route which circumvents the former party wall between the houses and hotel, and provides a mechanism which would involve low level burning for some time which eventually reached the much larger fuel load in the roof over the main section of the hotel.

External fire spread – The fire may have spread externally via insulation materials which pass across a line of compartmentation.

Figure 8 – Insulated pipes in lightwell to the rear of the hotel
Image taken from drone video footage courtesy of Devon & Somerset Fire and Rescue Service taken on 28th October, prior to fire escalation at around 10:30

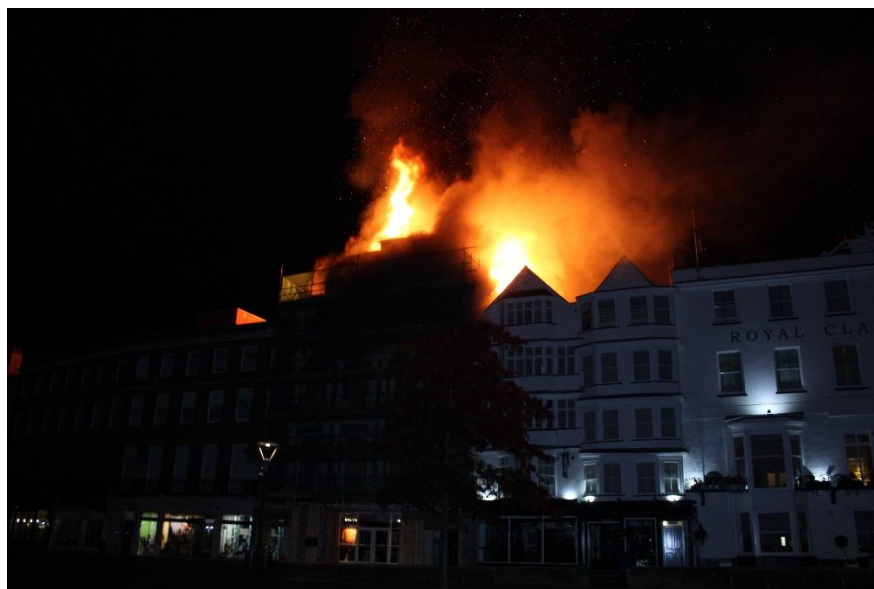
The first stage covers the start of the fire to full involvement of the building of fire origin. This is considered to have taken place between approximately 05:00 and 06:00. Photographs taken between 05:13 and 05:30 indicate that some sort of flashover occurred throughout the internal volume of the building of fire origin. This intense fire generated considerable radiant heat to cause further fire development onto the roof of the part of the hotel in the medieval houses above the public house, see Figure 9.

Figure 9 – One of first photographs of fire taken by a hotel guest shortly after evacuating

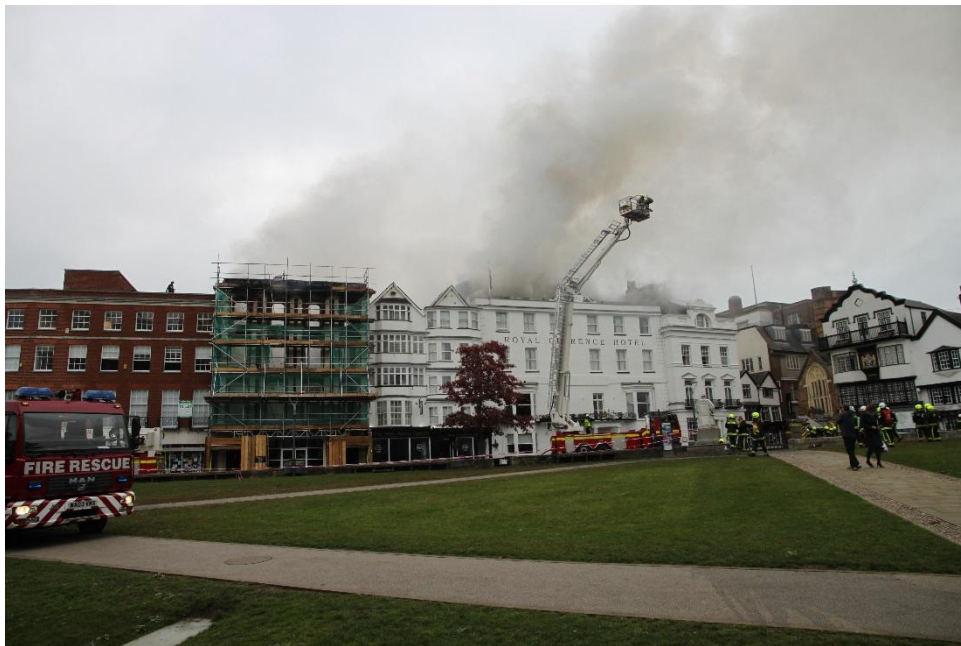
The third stage of fire development is less straightforward. Information and photographs from the Fire and Rescue Service indicate that the fire was under control for well over an hour, with low energy, light smoke rising from the roof of the hotel, see Figure 10. At around 10:30, the fire suddenly escalated, with a high energy, dark smoke plume, indicating a rapid increase in the burning rate and the quantity of materials involved in the fire, see Figure 10 and Figure 11. Given the lack of significant smoke over such an extended period of time, it is BRE's opinion that the fire became confined to a smouldering material or materials, and/or a material capable of sustaining a small flame over an extended period of time, then encountering a more flammable material and escalating from this.

Figure 10 – Light smoke rising from the roof of the hotel
Image courtesy of Devon & Somerset Fire and Rescue Service taken at 10:27 on 28th October 2016

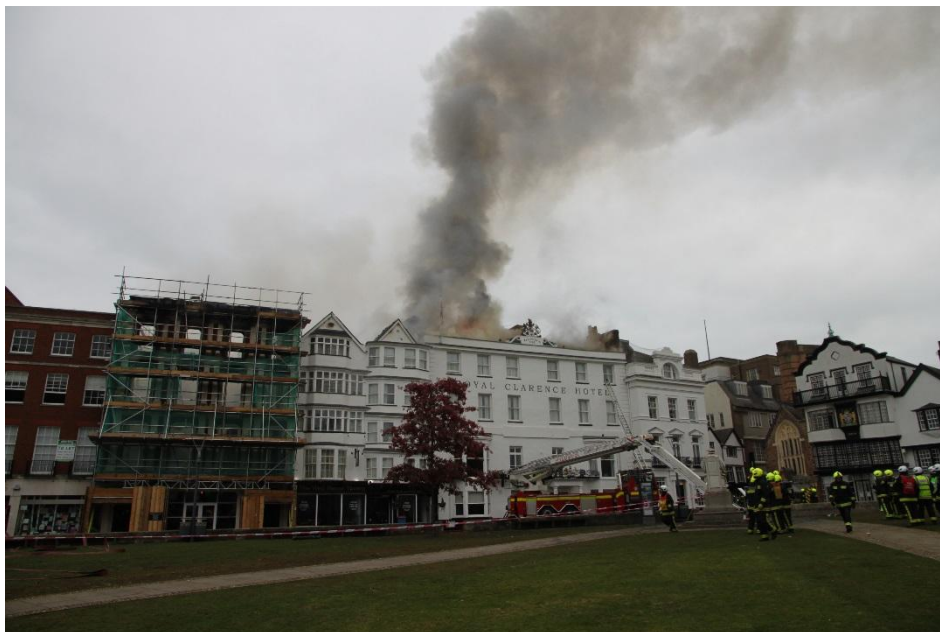
Figure 11 – Darker smoke rising from the roof of the hotel
Image courtesy of Devon & Somerset Fire and Rescue Service taken at 10:37 on 28th October 2016

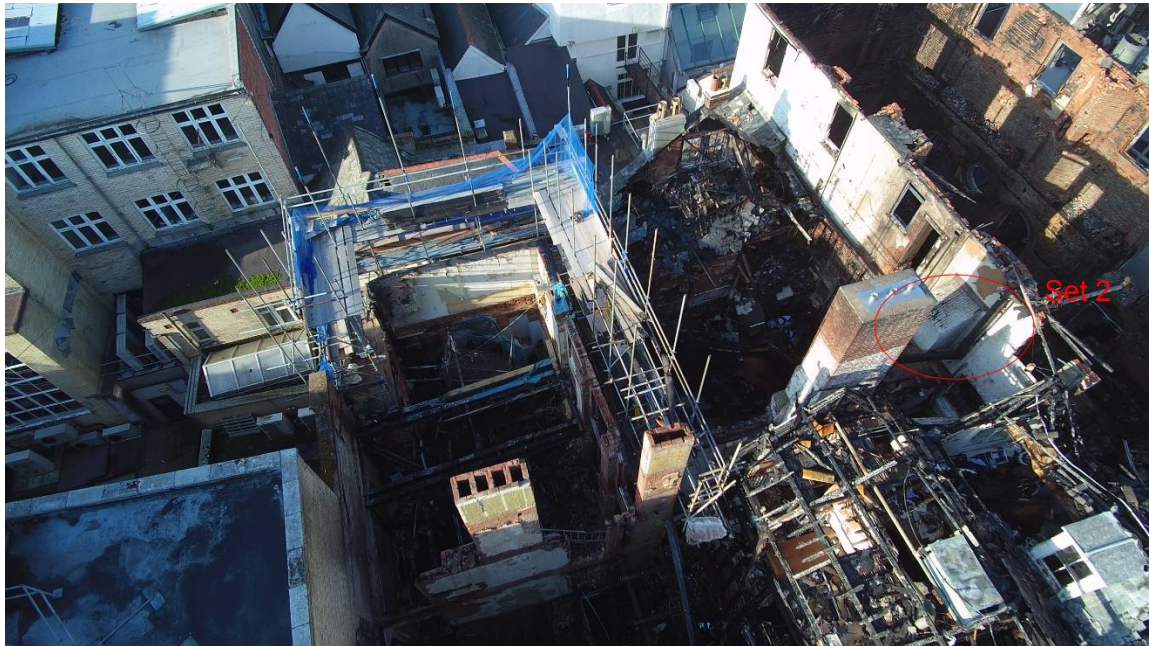
None, as it was not possible to obtain samples of the lagging material covering the pipes to the rear of the hotel to examine their fire performance; the pipework and lagging had been removed prior to the site visit.

Figure 12 – Remains of set of pipes (Set 2) shown in Figure 8; Set 1 is no longer visible but appears to have been destroyed by the fire
Image from drone video footage courtesy of Devon & Somerset Fire and Rescue Service taken on 31st October, after the fire had been extinguished
