DEVON &
SOMERSET
FIRE & RESCUE SERVICE

Cathedral Yard Exeter Fire

Devon & Somerset Fire & Rescue Service

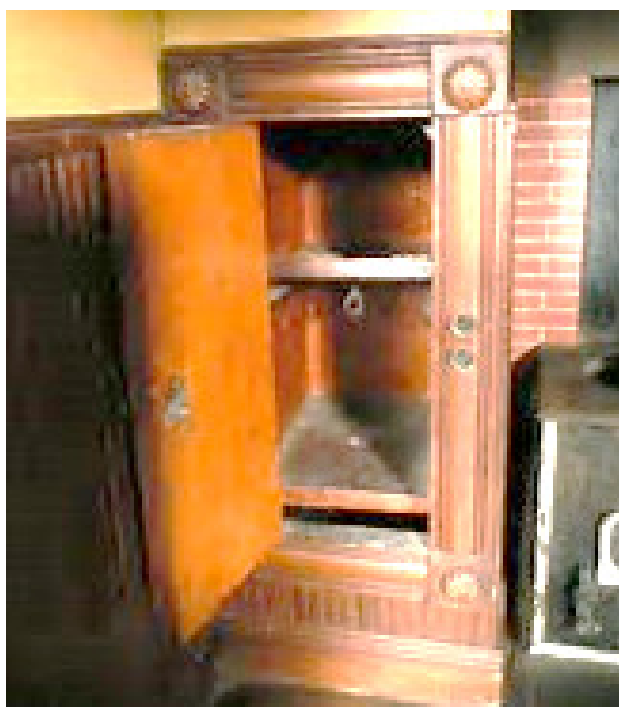
This example picture shows a dumb waiter in a void which would reach from the kitchen to various floors in the building. (Library pic not from Royal Clarence)

Waste shafts, natural ventilation stacks, bell pulley routes and dumb waiters; such voids, often interconnecting, are extremely hazardous to a traditional building, providing fire, smoke and the products of combustion with an easy route by which to spread.

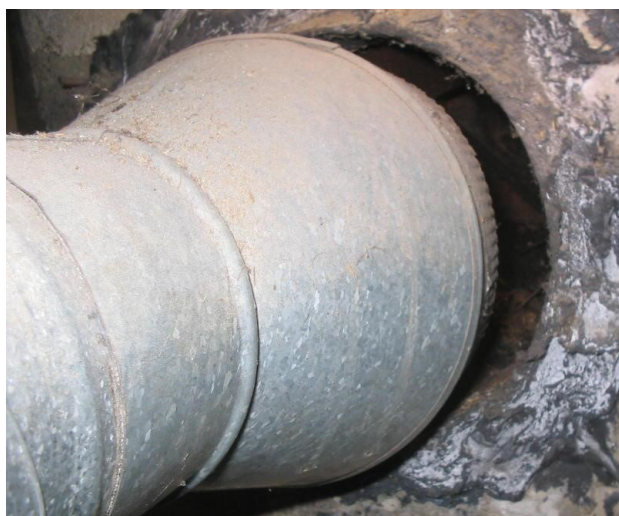
This example picture shows that the flue is not correctly fitted, allowing smoke and fire to travel through the void. (Library pic not from Royal Clarence)

Chimney fires can spread to other parts of the building due to cracked or faulty flues or where timber joists project into the flue way.

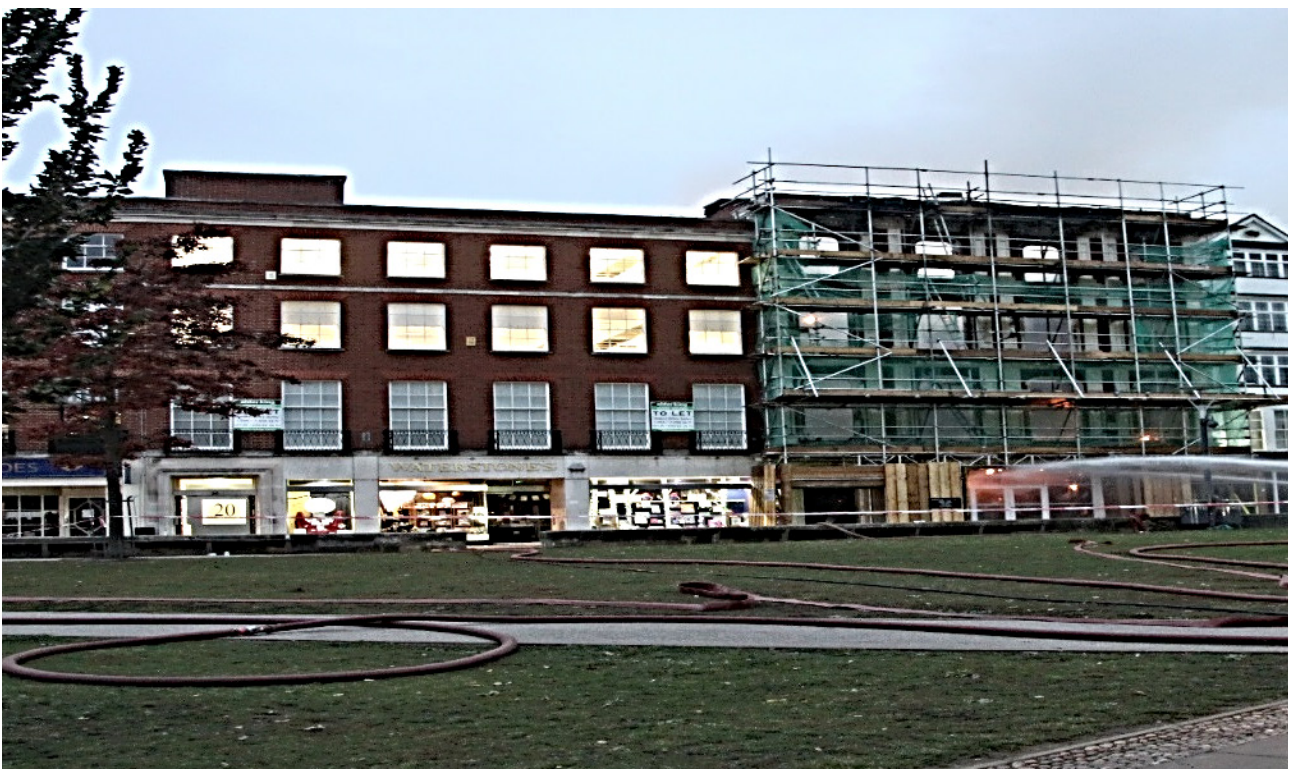
Fig 13. Sector 2 No 20 during the fire. Photo taken at 07:49

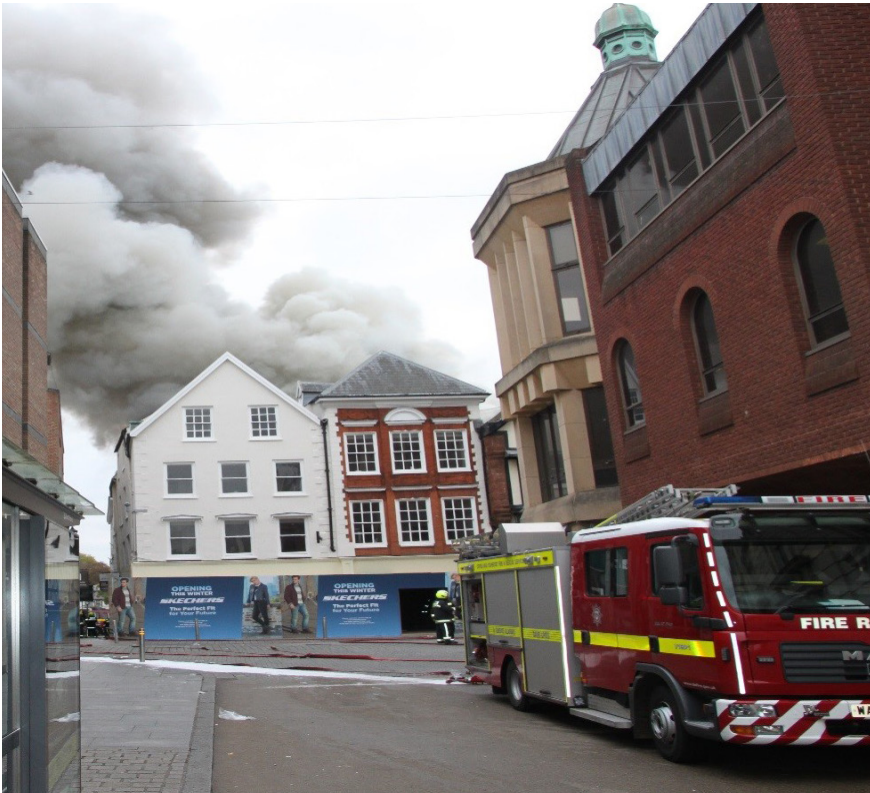
Fig 14. Photo shows the view of sector 3. Photo taken at 11:45

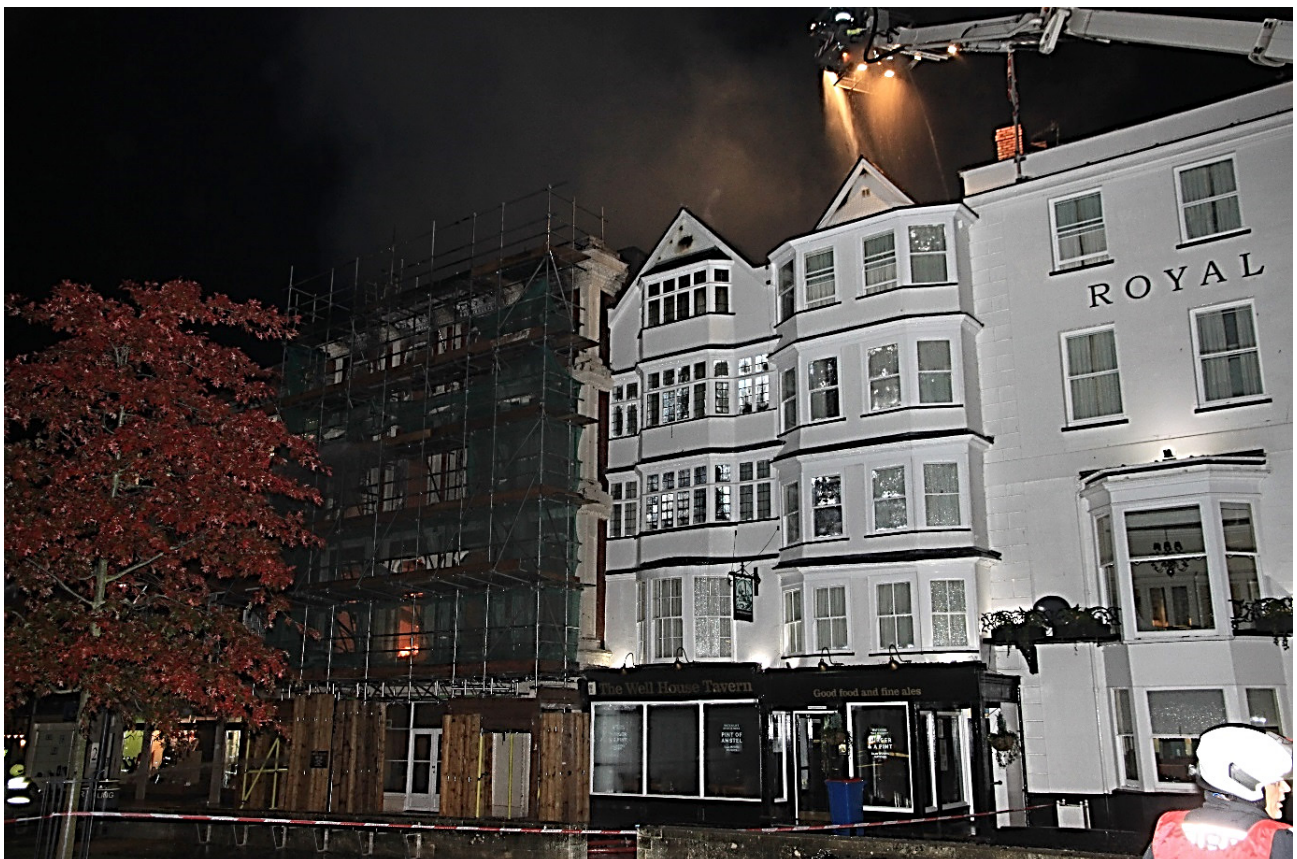
Fig 15. Sector 4 in front of the hotel. Photo taken at 06:53

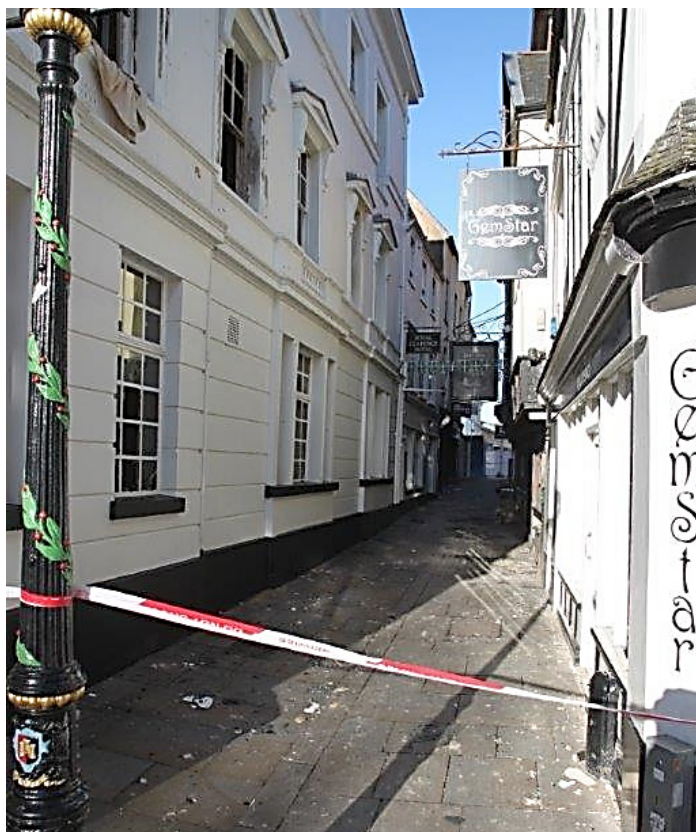
Fig 16. Sector 5 St. Martin's Lane

Sector 5 was established and disbanded a number of times throughout the incident within St. Martin's Lane, this was due to the risk assessment of the commanders changing, based on the changing dynamics of the incident and risks that were posed to fire crews. Sector 5 contained access to a number of shops including a bakery, a jewellers and also provided access to The Ship Public House, and expanded into Cathedral Close which included a number of shops, restaurants and domestic premises.

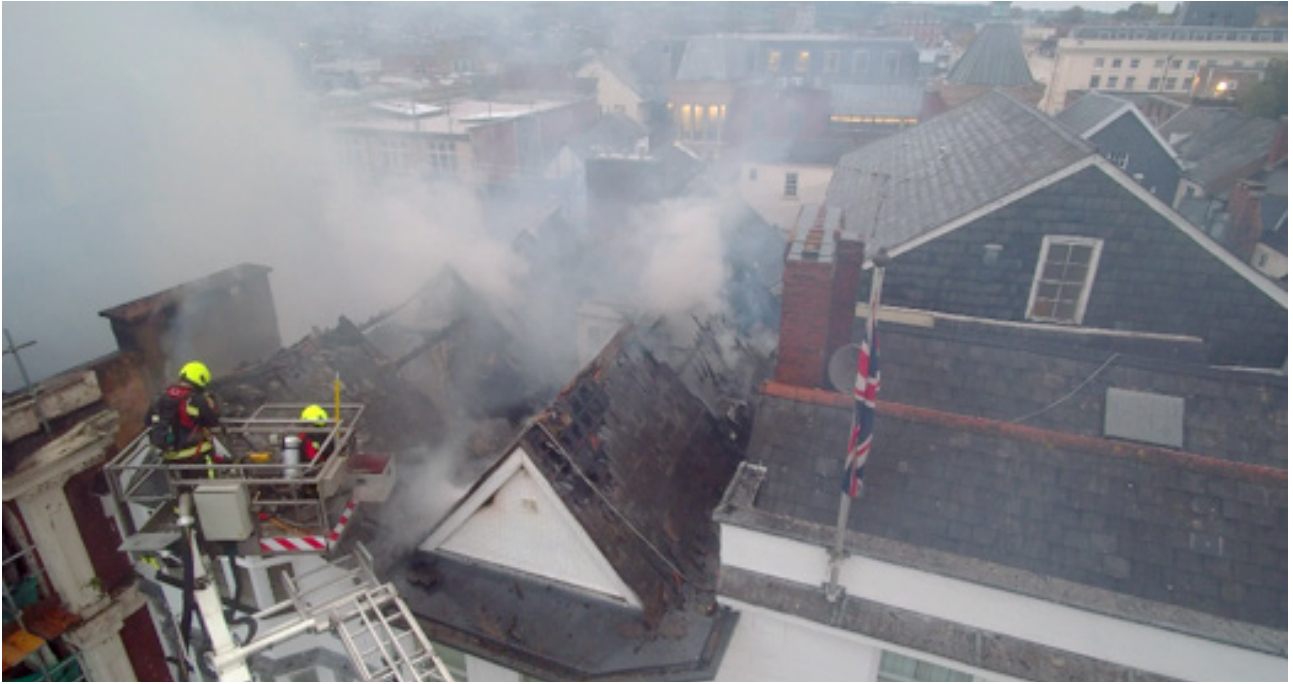
To ensure the safety of crews they were withdrawn from fighting the fire from within the hotel, only using the aerial ladder platforms outside of the hotel (Fig 18).

Fig 18. Aerial crews removing roof tiles looking for internal fire spread

At approximately 08:45 a multi-agency meeting was convened led by the fire & rescue service to identify the joint priorities of all agencies including the police, ambulance, city council and services providers. During this period, aerial crews were involved in stripping the pitched roofs above the Well House Inn pub and rooms number 401 and 402 (Fig 18).

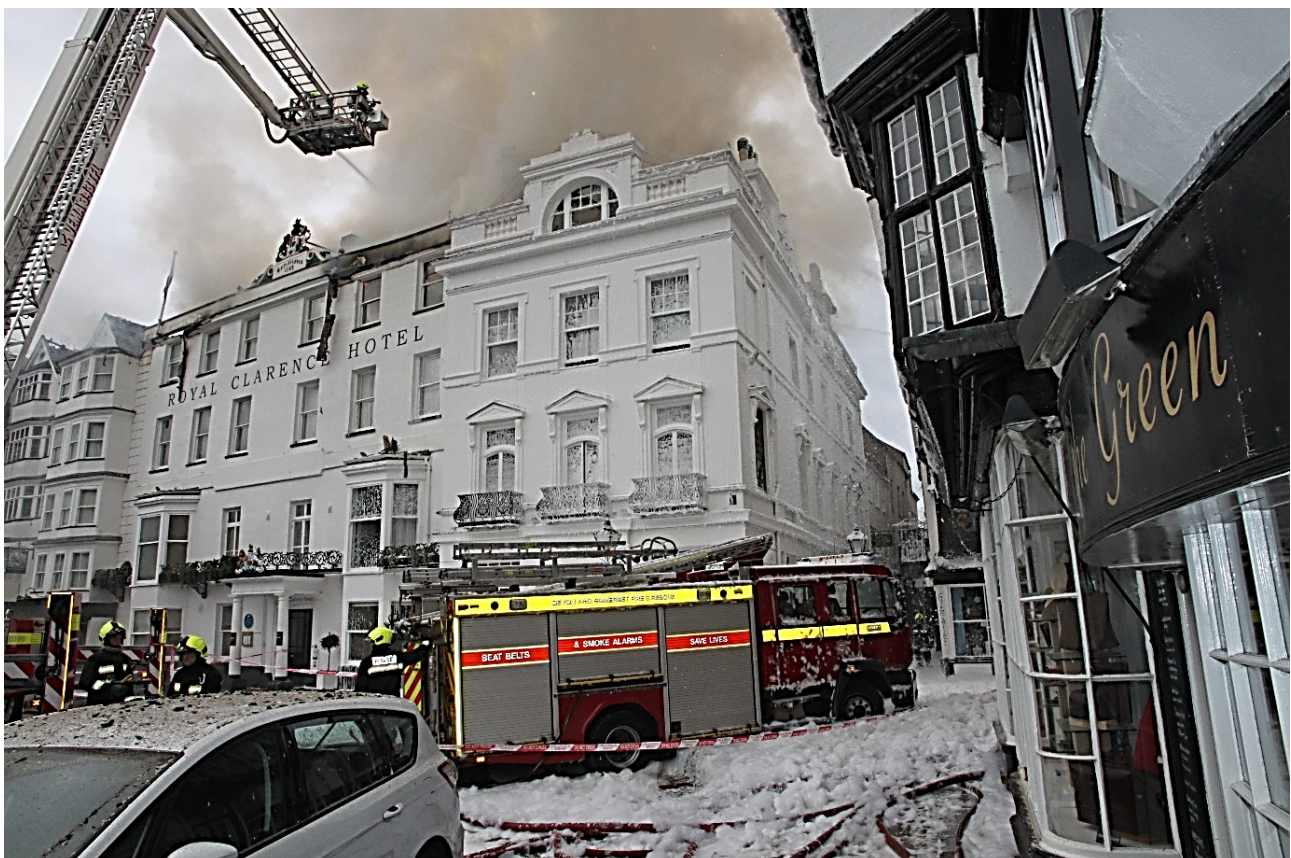
Fig 21. Photo showing sector 5 and the use of compressed air foam. Photo taken at 13:01

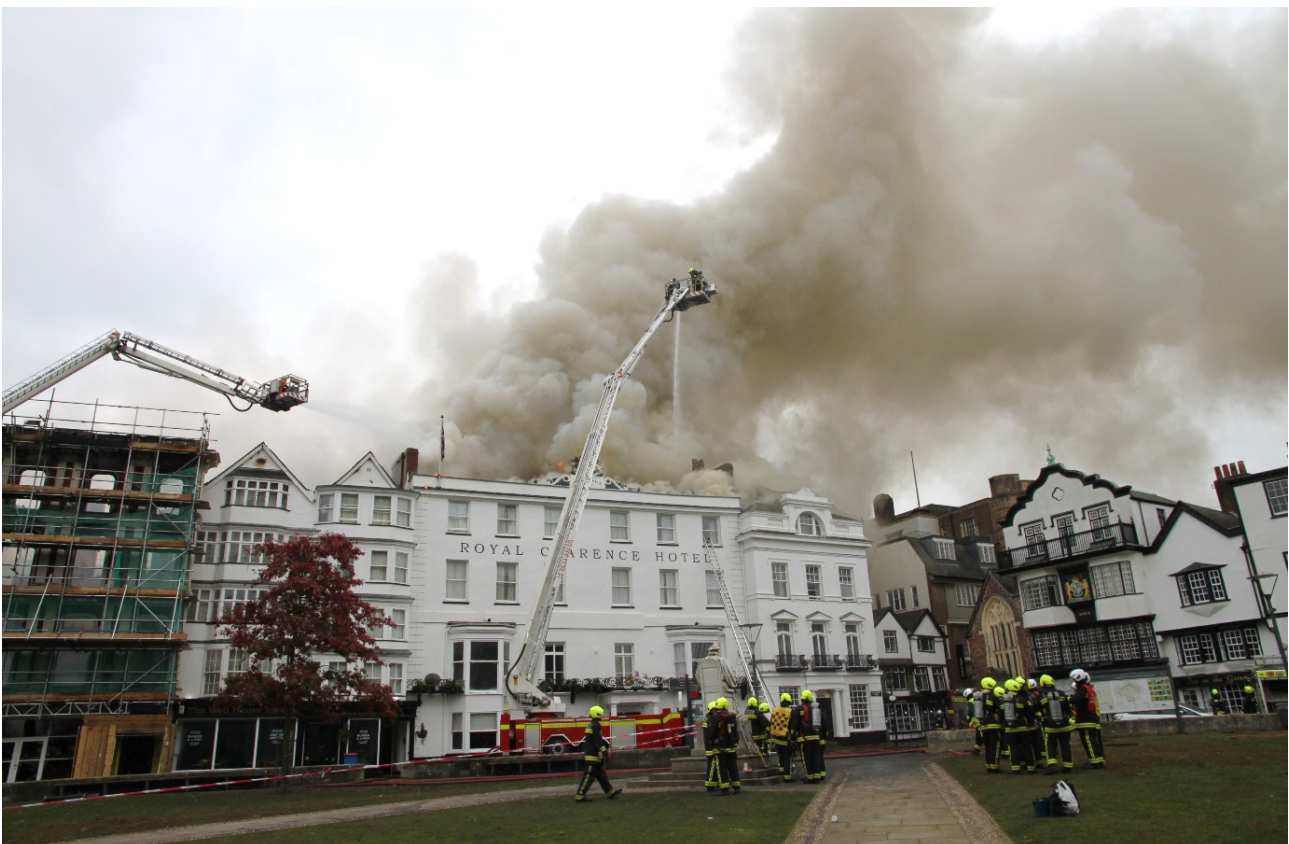
Aerial appliances were immediately re-established for firefighting as well as roof stripping, to protect the surrounding buildings and heritage of the hotel and the High Street (Fig 23). Due to the sudden development of the fire, crews were firefighting using hand held jets and the aerial appliances. Due to the number of hose lines being used from all sectors, the water supply was over-run leading to tactical decisions being made that the water should be diverted into the sectors that would allow the most effective firefighting. The greatest priority now changed from stripping the roof, to stopping the fire jumping across into Cathedral Close and spreading past the footprint of the hotel into the High Street.

*Fig 23. Photo showing the use of aerial appliances during the escalation of the incident.
Photo taken at 11:14*

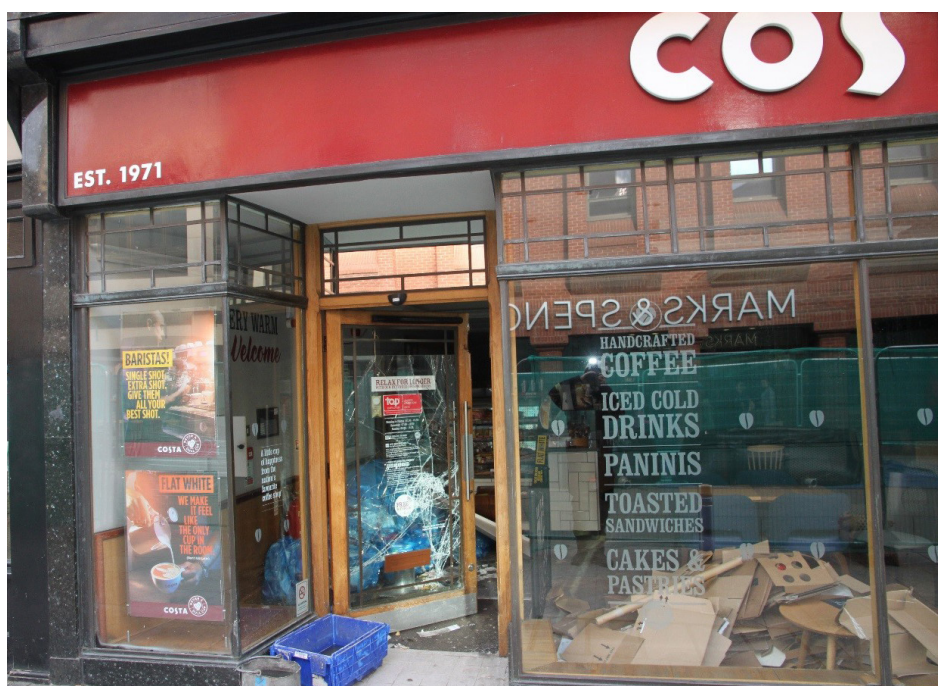
Fig 28. Photo shows that the crews stopped the fire spreading through this shop on the High Street

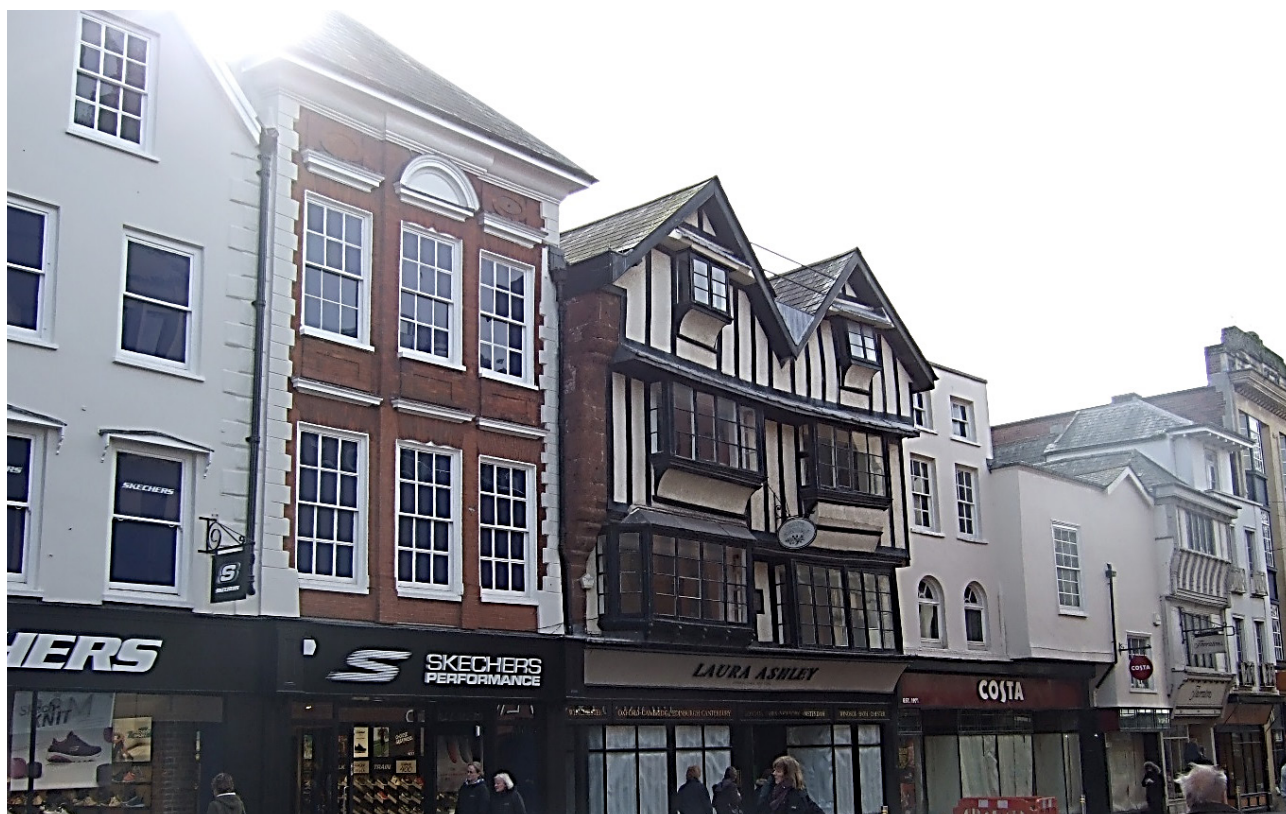
Fig 29. Photo showing the buildings on the High Street which are of significant historic importance saved by the fire crews
